Dry Gas Sealing Systems for Oil Sands Pumping Applications

Design Engineering Issues and Resolutions

By: Chandra Sivapuram, P.Eng.

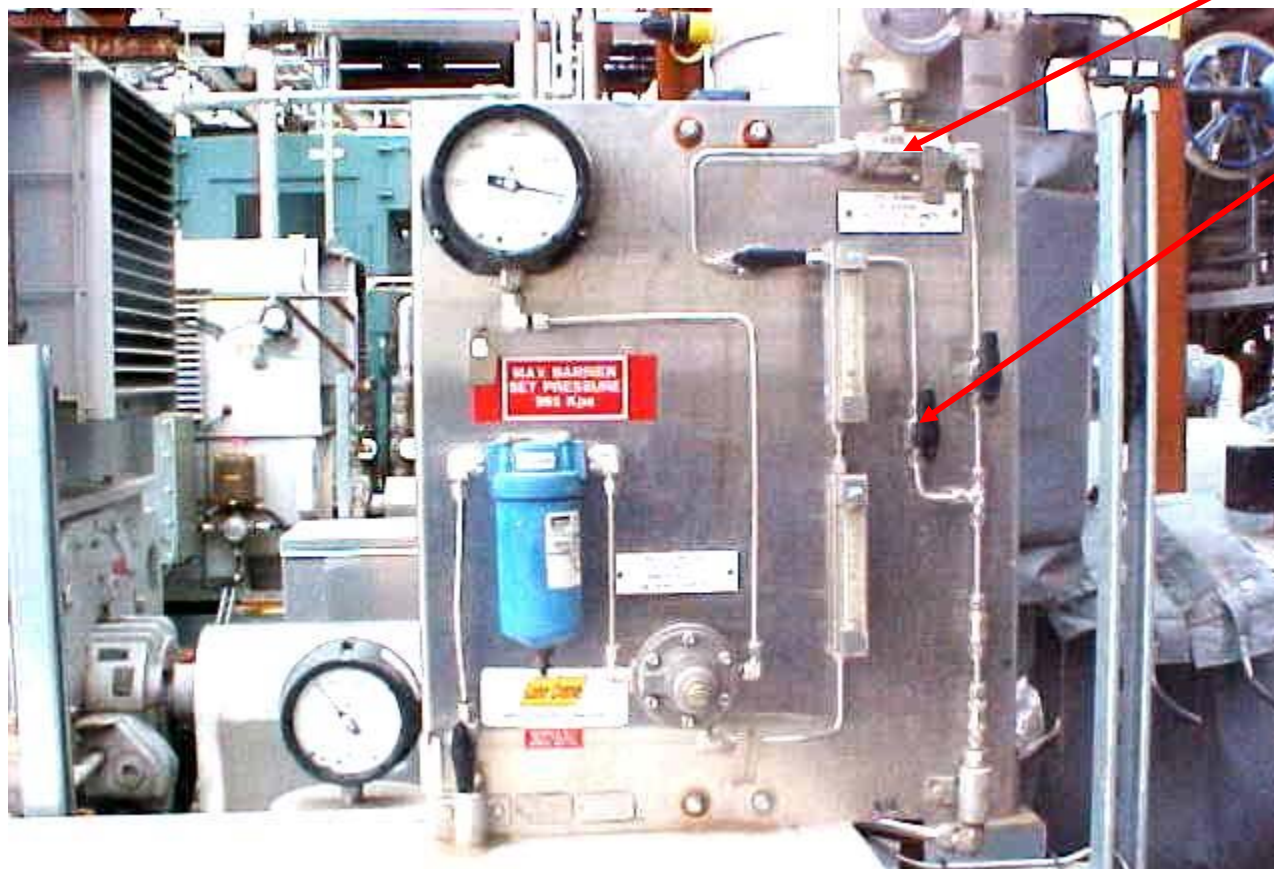
Nitrogen Gas Panel

Flow Turbine meter

Turbine
meter by-
pass line
with
isolation
valve

Gas control Panel with single flow turbine meter for over hung pumps

- Use modified seal panel tubing with bypass line.
- Explore alternate flow meter that can withstand the minimum to maximum pipe flow, within acceptable accuracy and reliability.

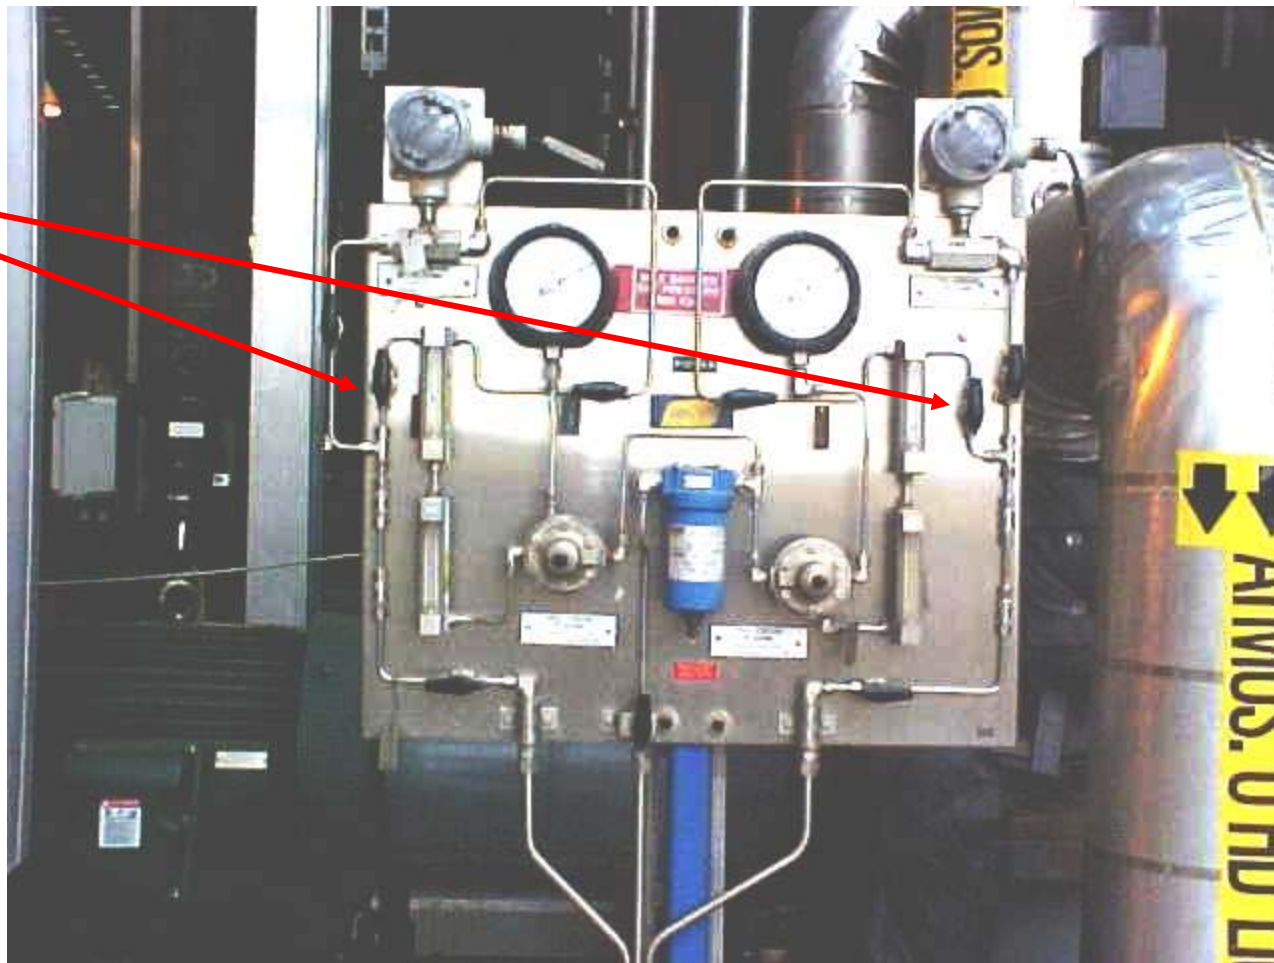
Nitrogen Gas Panel

Turbine meter
by-pass line
with isolation
valve

Gas control Panel with two flow meters for between bearing pumps

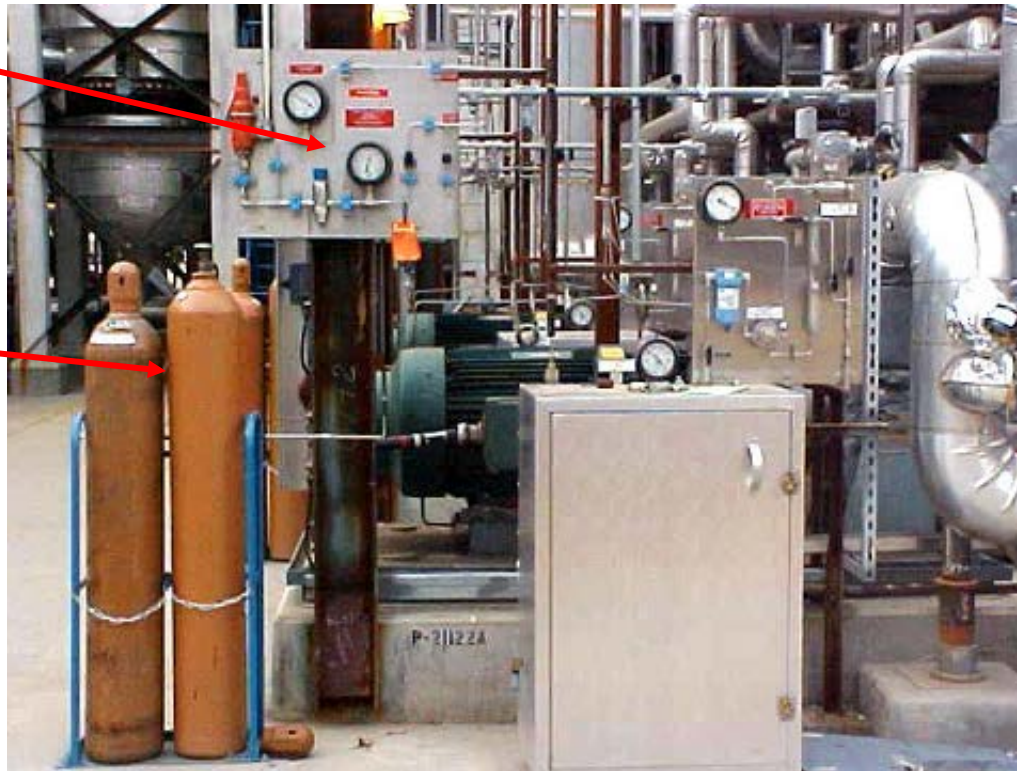
Nitrogen Booster Over-cycling issues

Additional Panel to
monitor cylinder
supply pressure
with safety valves

Back-up Nitrogen
Cylinders

Back-up nitrogen cylinder arrangement for DGSeals with boosters

- Install nitrogen back-up piping system with high pressure nitrogen cylinders.
- Design an auxiliary equipment data sheet in association with seal manufacturer and site rotating equipment engineer to improve booster design with better rider band material to increase reliability.

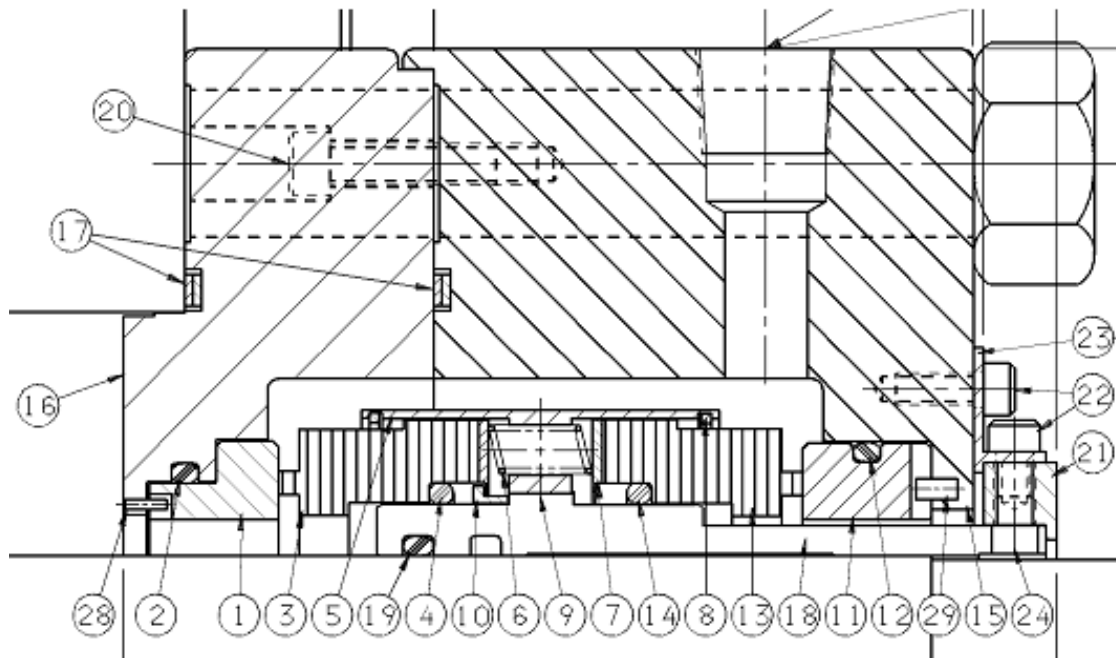
Seal Failure Analysis Report - P-21113A/B

Seal Type & Size : 2800 Double Cartridge, 3.5 seal head
